Inspection Report

2299 Aloha Rd.
Kaneohe, HI 96744

Wednesday, July 15, 2020

RE: Report No. 1001
2299 Aloha Rd.
Kaneohe, HI
96744

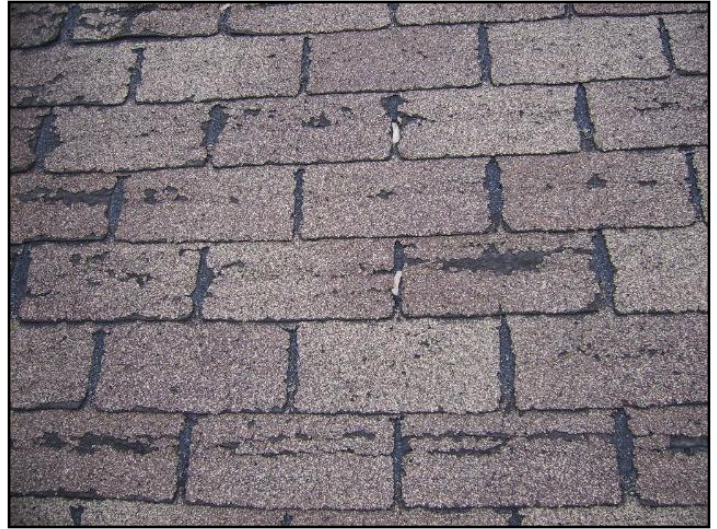
Observed area of major granule loss at the top of the roof. Recommend further evaluation for replacement by qualified roofer.

2. Granule loss

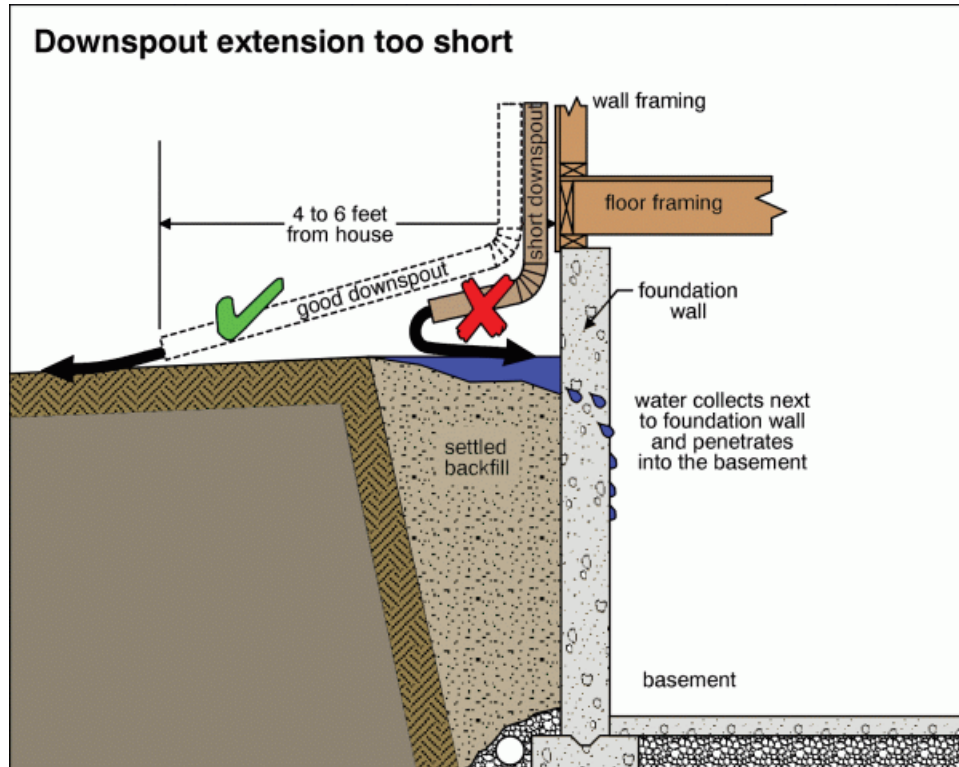
Condition: • [Discharge too close to building](#)

14. Downspouts end too close to building

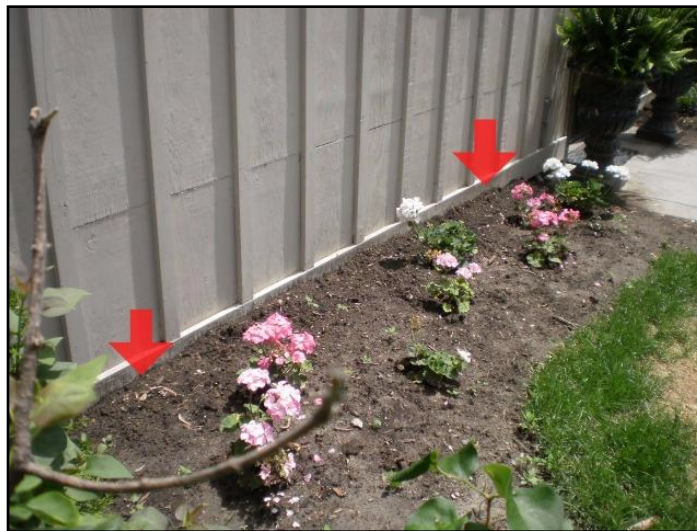
Condition: • [Too close to grade](#)

15. Too close to grade

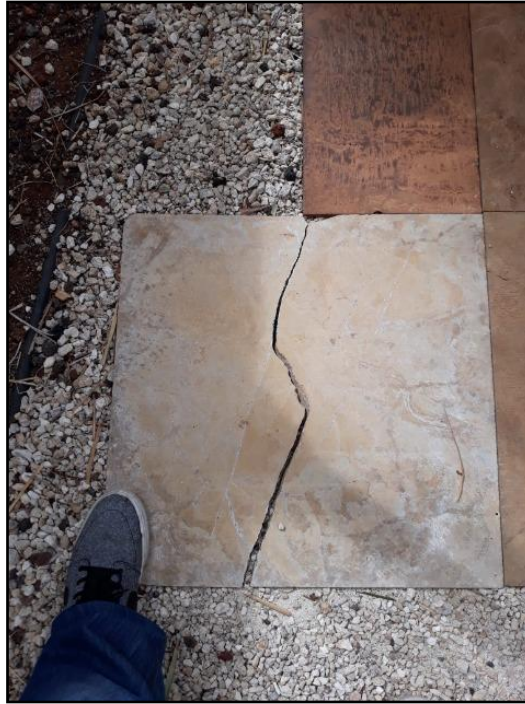
Condition: • Observed one paver at the rear patio to be cracked. Recommend repair or replacement by qualified contractor.

16. Crack- Patio paver

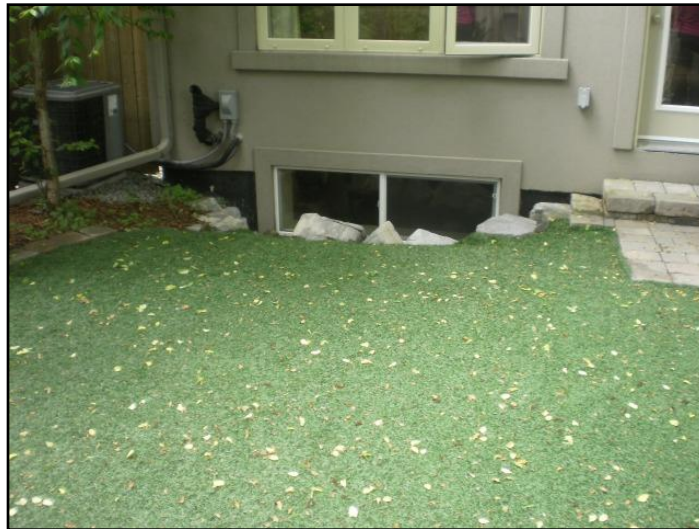
Condition: • [Improper slope or drainage](#)

17. Improper slope

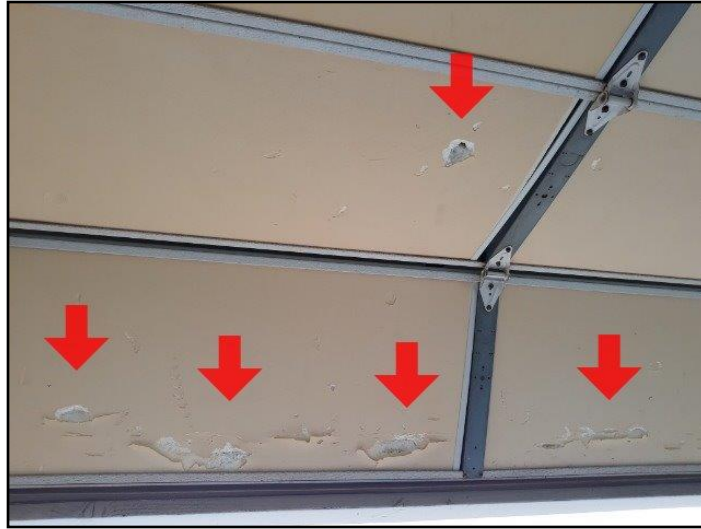
Damages observed on garage vehicle door interior. Garage vehicle door still properly operating at this time. Recommend further evaluation for repair by qualified contractor.

18. Damage- garage vehicle door

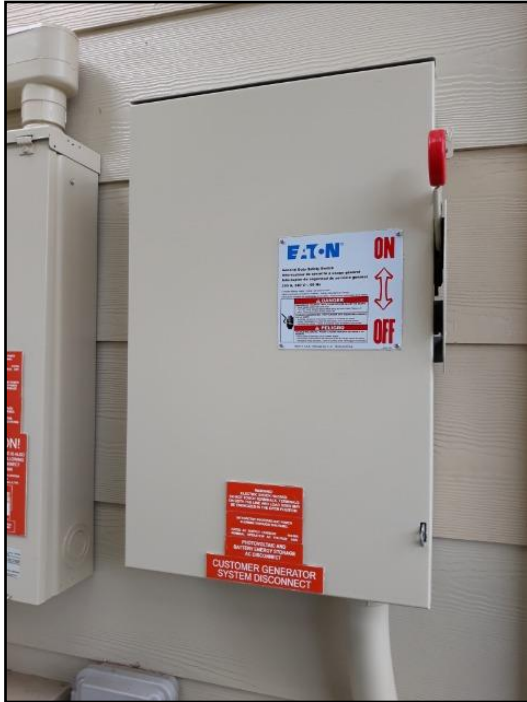
General: • Present. Solar panels and systems not tested as an InterNACHI standard of practice. Recommend further evaluation by qualified solar technician.

25. Solar panels and systems

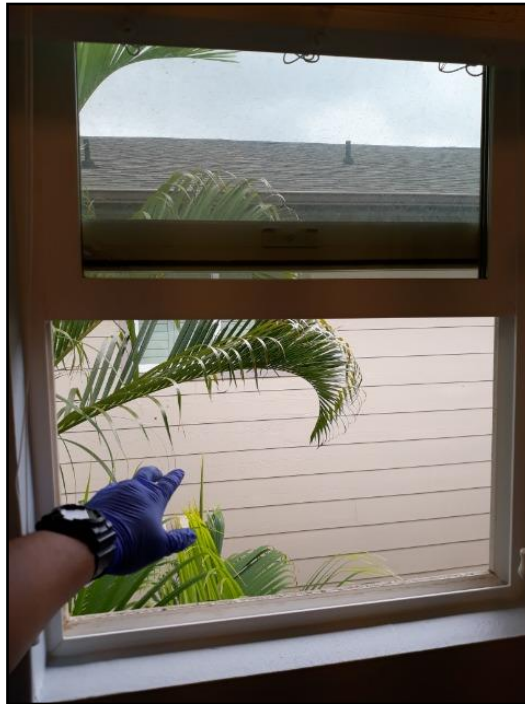
Window screen missing in master bathroom. Recommend replacement to keep pests from entering home.

90. Missing window screen- bathroom
