Inspection Report

2299 Aloha Rd.
Kaneohe, HI 96744

Wednesday, July 15, 2020

RE: Report No. 1001
2299 Aloha Rd.
Kaneohe, HI
96744

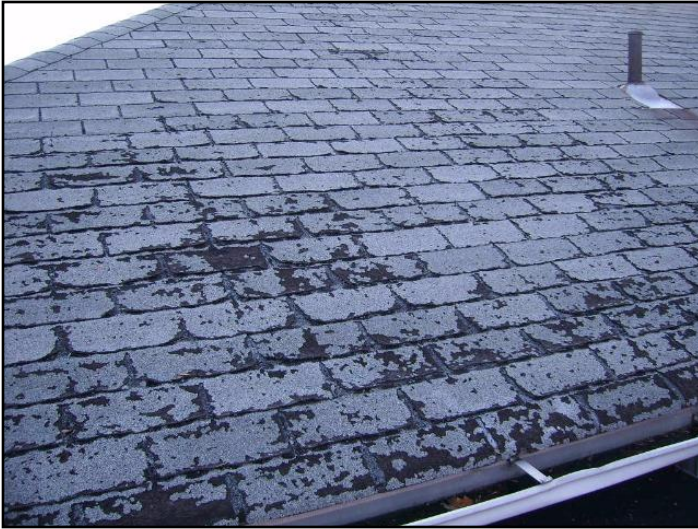
1. Granule loss

Condition: • [Granule loss](#)

Observed area of major granule loss at the top of the roof. Recommend further evaluation for replacement by qualified roofer.

Implication(s): Chance of water damage to contents, finishes and/or structure

Task: Replace

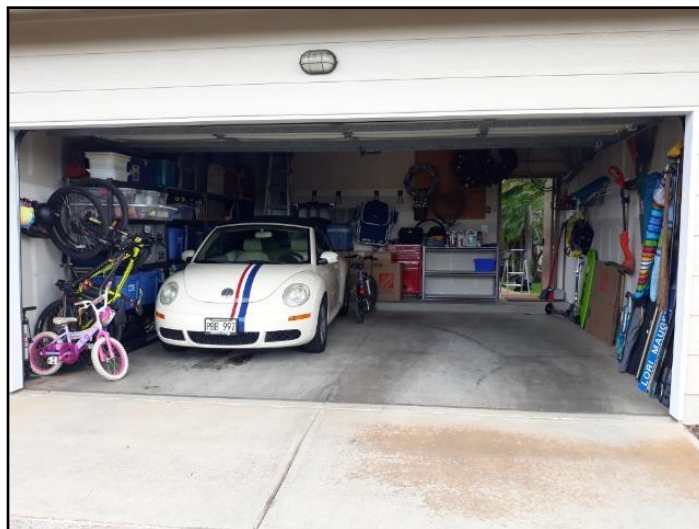
9. Garage

Detached garage inspected. Walls and flooring in generally good condition. No ceiling to note. Plywood sheathing held together by hurricane ties and clips. Garage man-door has self closing device at the top of the door. Garage hardware, vehicle door, motor, sensor, and controls tested and functional.

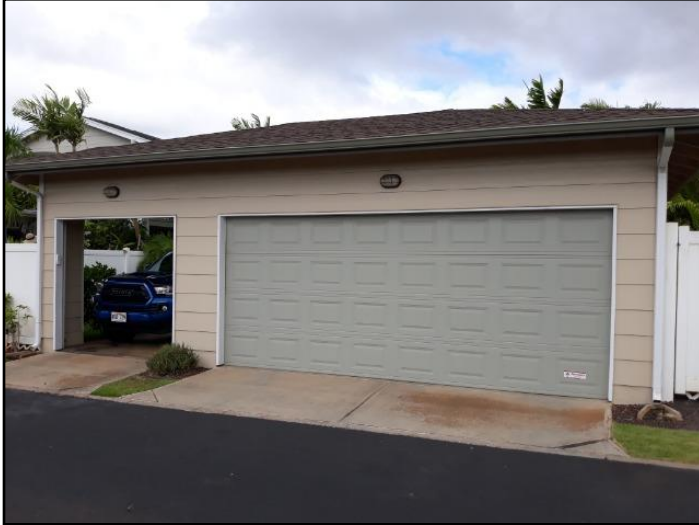
10. Garage door

Garage hardware, vehicle door, motor, sensor, and controls tested and functional.

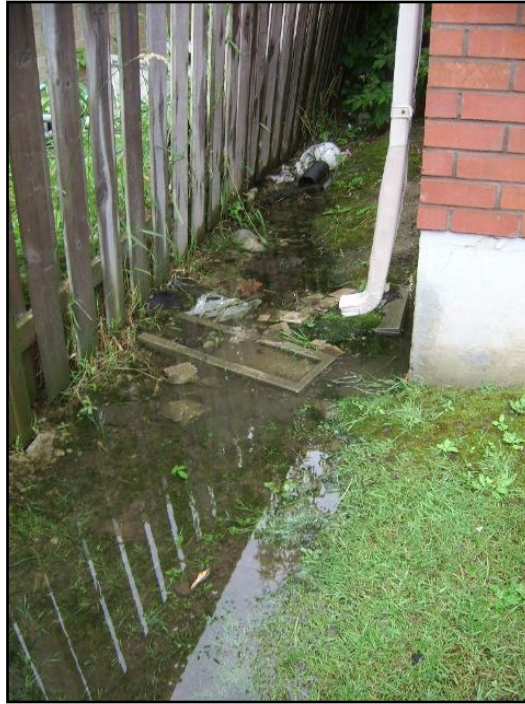
14. Downspouts end too close to building

Condition: • [Discharge too close to building](#)

Implication(s): Chance of water damage to contents, finishes and/or structure

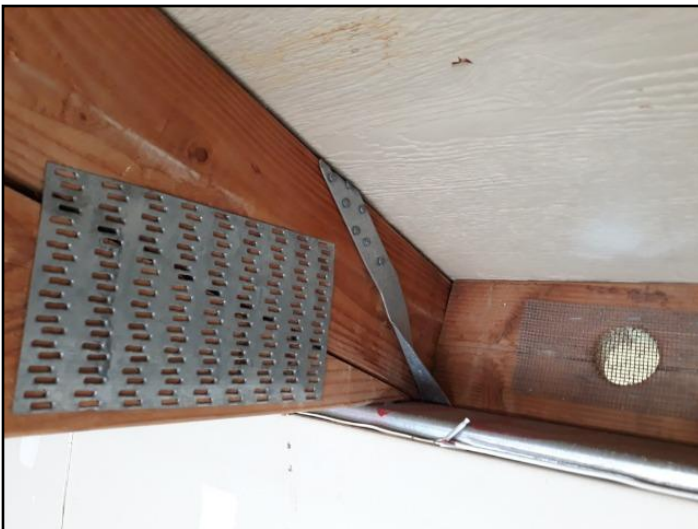
19. Hurricane ties

Attic space inspected. Average condition. Plywood sheathing held together with hurricane clips. Fiber glass insulation and foil barrier in attic space.

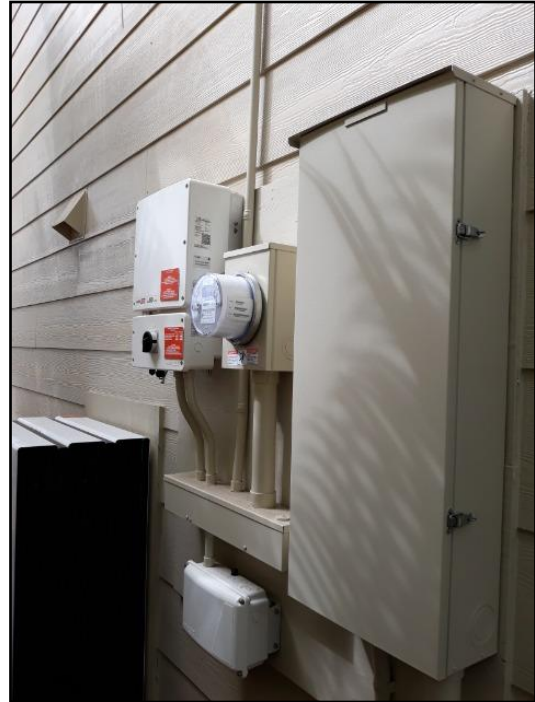
26.

General: • Present. Solar panels and systems not tested as an InterNACHI standard of practice. Recommend further evaluation by qualified solar technician.

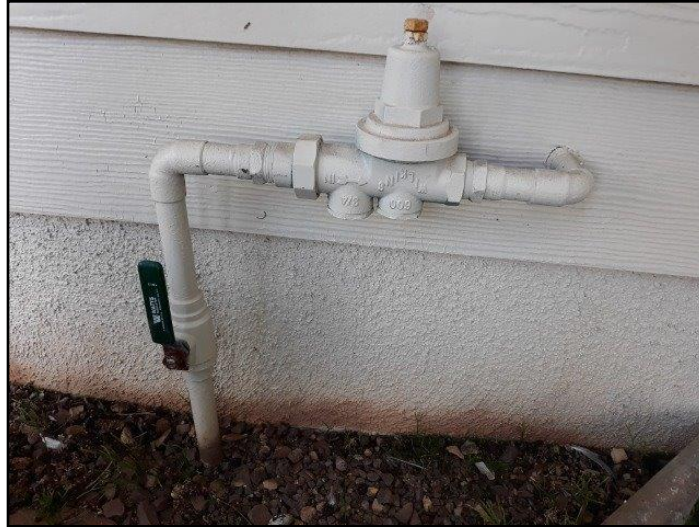
55. Water shut-off and pressure regulator

Tested and functional.

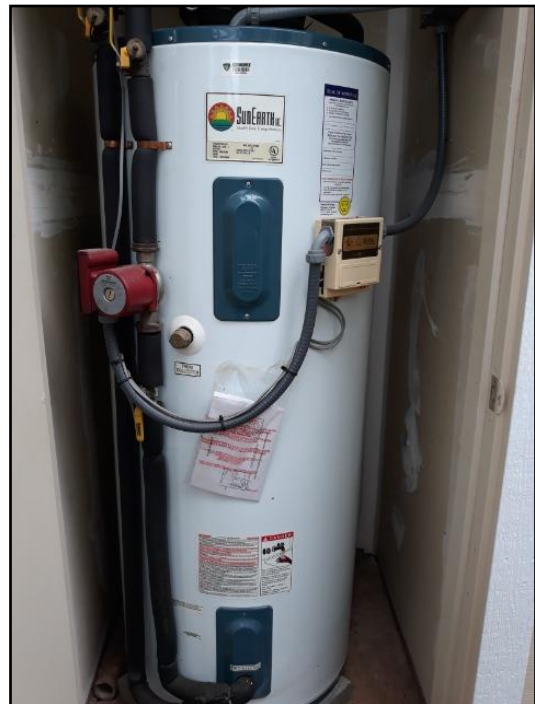
57. Water heater

Conventional solar electric water heater located at side exterior utility closet. 80 gallon capacity with TPR valve properly draining. Timer present and in use.

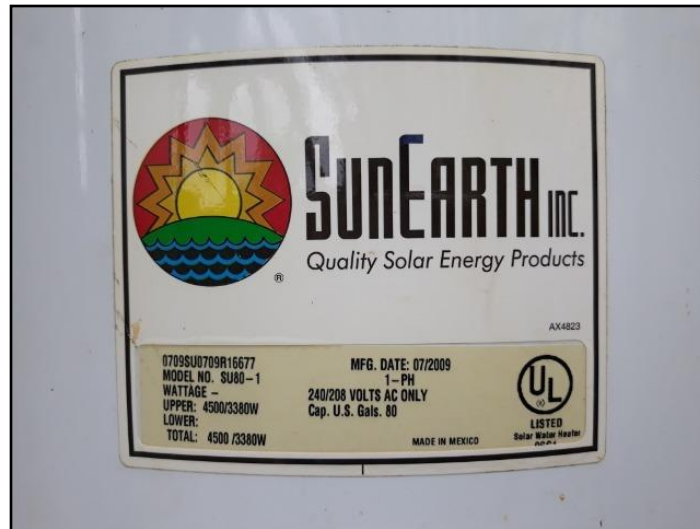
58. 80 gallons

- 80 gallons

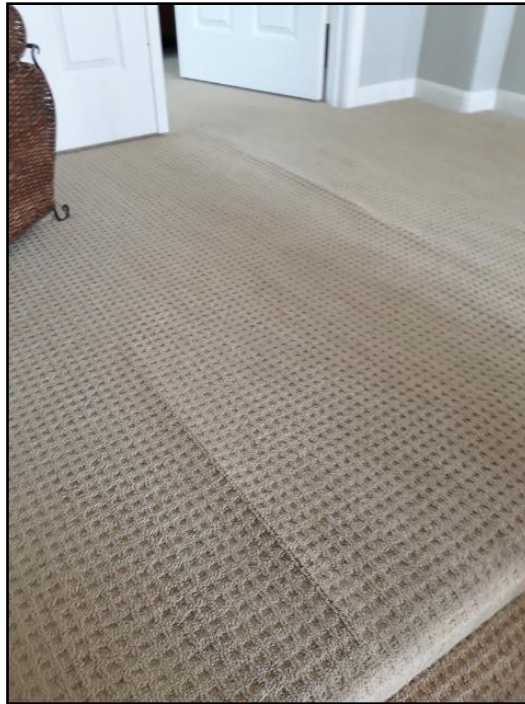
64. *Carpet*

Carpet in average condition. Typical wear, tear, and buckling.

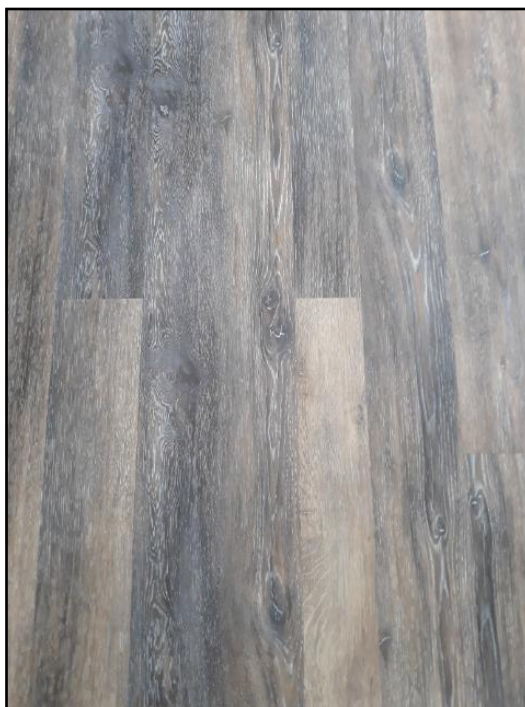
65. Laminate

Laminate flooring in generally good condition.

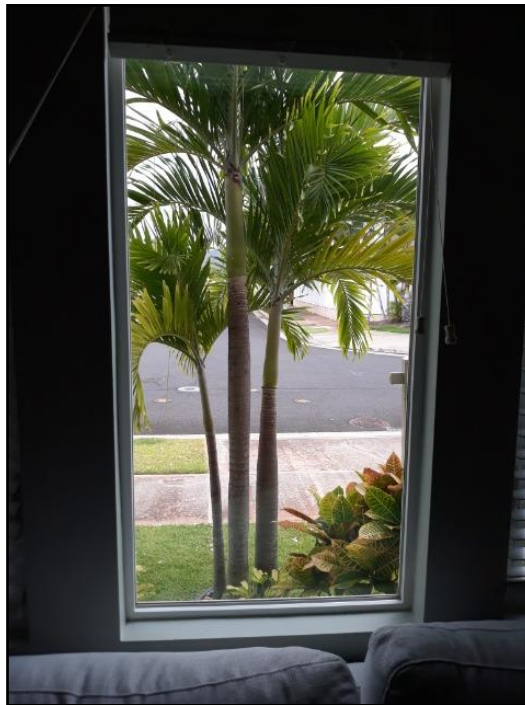
68. *Fixed*

Inspected. No damages.

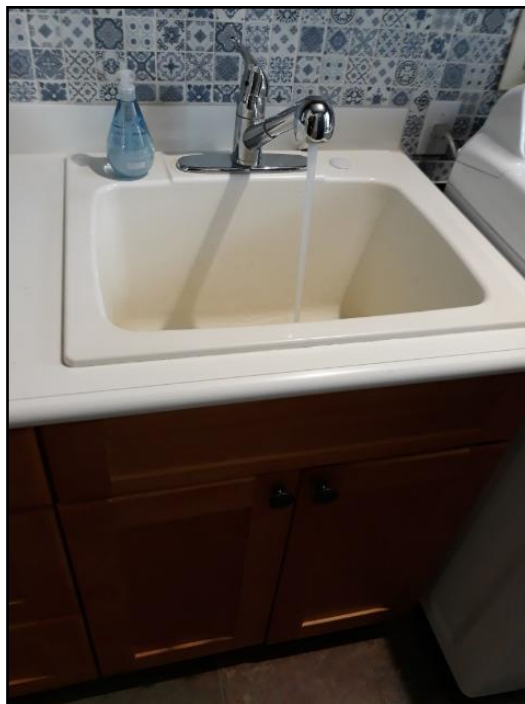
85. Laundry tub

- Laundry tub
Tested and functional.

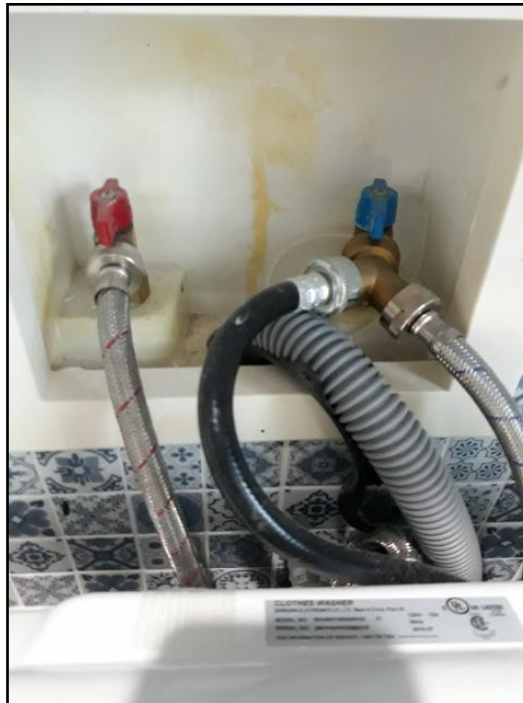
86. Water supply and standpipe

Tested and functional.

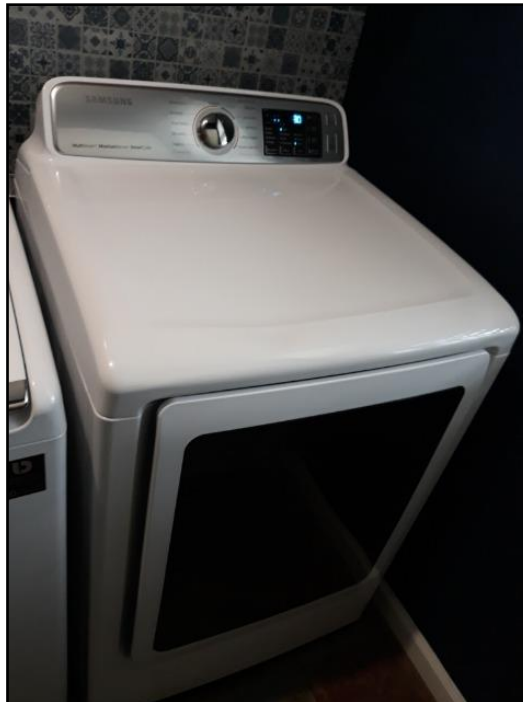
87. Dryer

Tested and functional. Venting to the exterior.

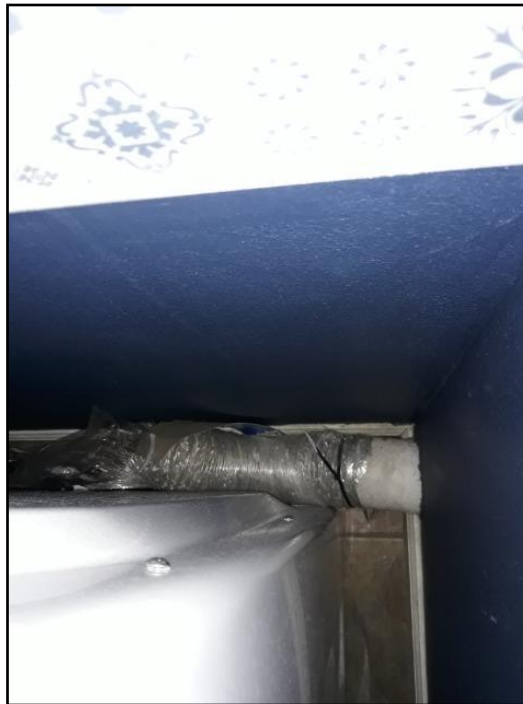
88. Clothes dryer vented to exterior

Tested and functional.
